Status: Closed
Work Order: N/A
Joint Use: Yes
Joint Quantity: 2
Street Light: No

Priority: Critical
Assigned User: None
Location: [40.71417, -99.08288](#)
[All Images](#)
[View Attached Files](#)

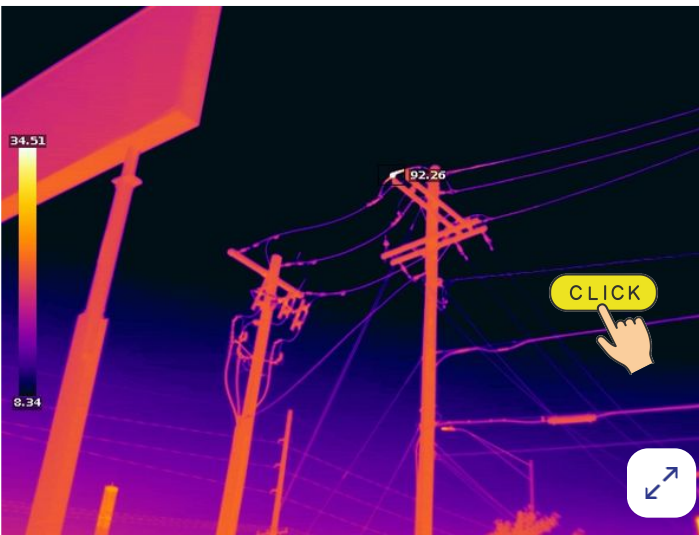
Date: Jul 21, 2025, 4:49:02 PM CDT
AtmT: 24°C **Dist:** 37.13ft
E: 0.85 **AmbT:** 24°C
Notes: n/a

"East most insulator and jumper showing significant hot spot, near 100C. "

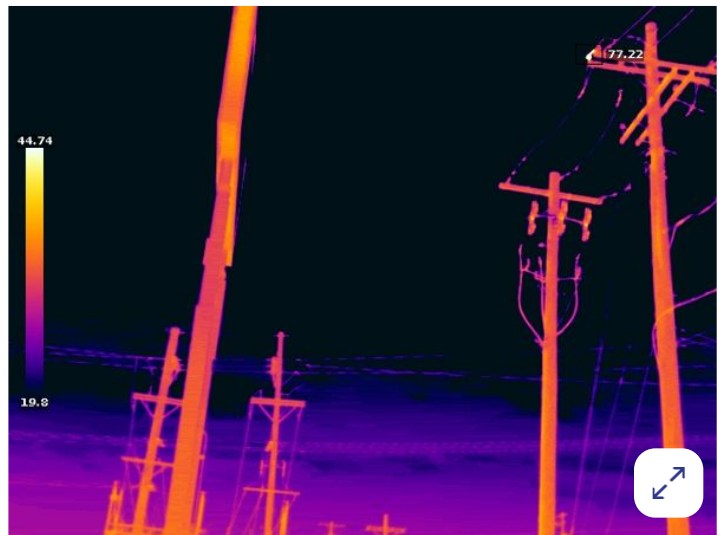
Date: Jul 22, 2025, 4:33:19 PM CDT
AtmT: 20°C **Dist:** 46.15ft
E: 0.85 **AmbT:** 20°C
Notes: n/a

Visible confirmation shows melted insulation and excessive pitting in the bolted clamp on the jumper, also extremely hot to the touch. Repaired by Utility on 7/23.
