Status: Closed
Work Order: N/A
Joint Use: Yes
Joint Quantity: 2
Street Light: No

Priority: Critical
Assigned User: None
Location: [40.71417, -99.08288](#)
[All Images](#)
[View Attached Files](#)

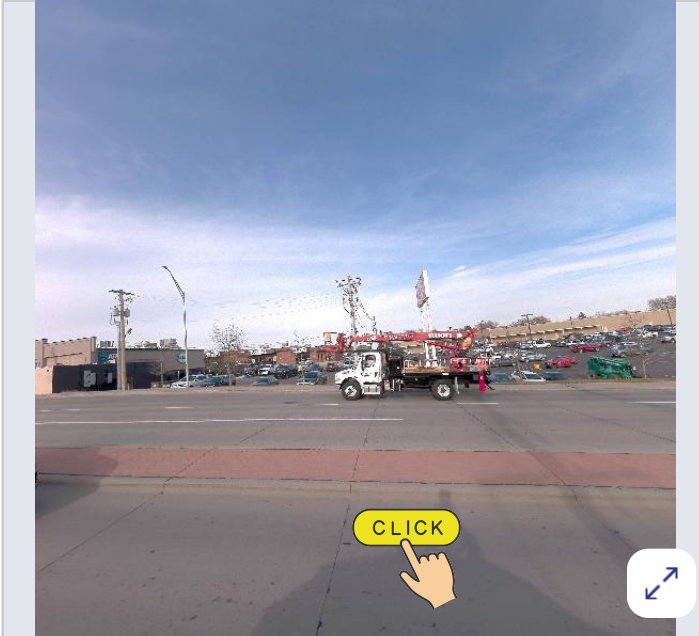
Date: Dec 13, 2023, 12:57:05 PM CST

Visible confirmation shows melted insulation and excessive pitting in the bolted clamp on the jumper, also extremely hot to the touch. Repaired by Utility on 7/23.
